DEPARTMENT OF TRANSPORTATION

Contract #: 04-0120F4Cty: SF/ALA Rte: 80 PM: 13.2/13.9File #: 1.28**WELDING INSPECTION REPORT****Resident Engineer:** Casey, William**Address:** 333 Burma Road**City:** Oakland, CA 94607**Report No:** WIR-028688**Date Inspected:** 24-Oct-2012**Project Name:** SAS Superstructure**OSM Arrival Time:** 700**Prime Contractor:** American Bridge/Fluor Enterprises, a JV**OSM Departure Time:** 1730**Contractor:** American Bridge/Fluor Enterprises, a JV**Location:** Job site**CWI Name:** N/A**CWI Present:** Yes No**Inspected CWI report:** Yes No N/A**Rod Oven in Use:** Yes No N/A**Electrode to specification:** Yes No N/A**Weld Procedures Followed:** Yes No N/A**Qualified Welders:** Yes No N/A**Verified Joint Fit-up:** Yes No N/A**Approved Drawings:** Yes No N/A**Approved WPS:** Yes No N/A**Delayed / Cancelled:** Yes No N/A**Bridge No:** 34-0006**Component:** OBG**Summary of Items Observed:**

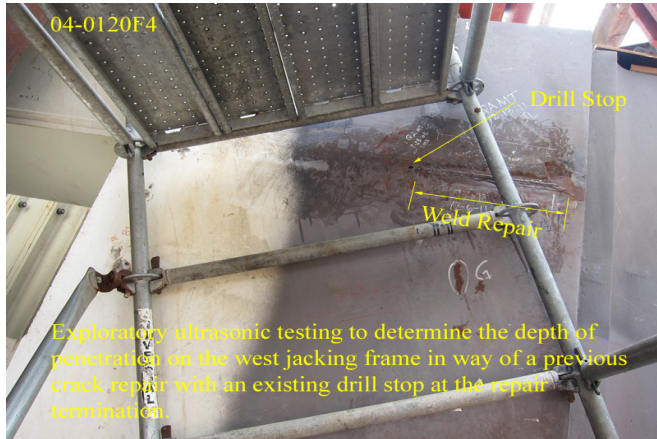
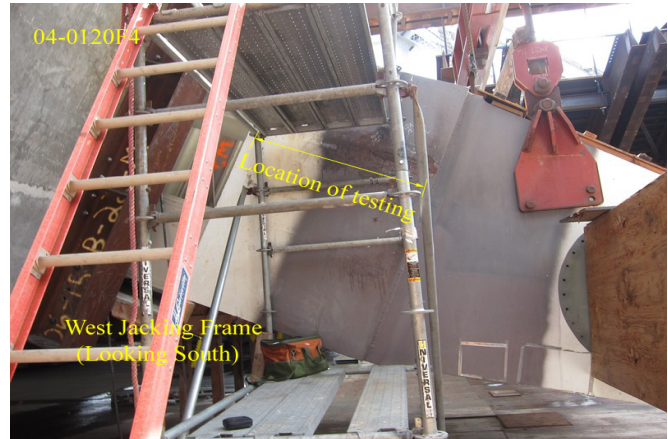
The QAI was tasked with performing exploratory ultrasonic testing to determine the depth of penetration on the west jacking frame in way of a previous crack repair with an existing drill stop at the repair termination. The location of repair as well as the surrounding area was ultrasonically examined by the use of a 70 and 45 degree probe in legs I/II. The required weld size of the tested weld was 14mm.

The exploratory ultrasonic testing showed that approximate penetration east of the repaired area to be between 12mm~18mm.

A 75mm area around the drill stop at the termination of the repair showed an approximate penetration between 8mm~11mm.

The repaired area 75mm west of the drill stop showed an approximate penetration between 13mm~30mm. The QAI observed multiple indications in the repair in leg II that appeared to be from the reinforcement of the weld.
